Magnolia Plantation Gin Barn

Historic Structure Report

2004
Historic Structure Report
Gin Barn
Cane River Creole National Historical Park
Magnolia Plantation
LCS#: 91561

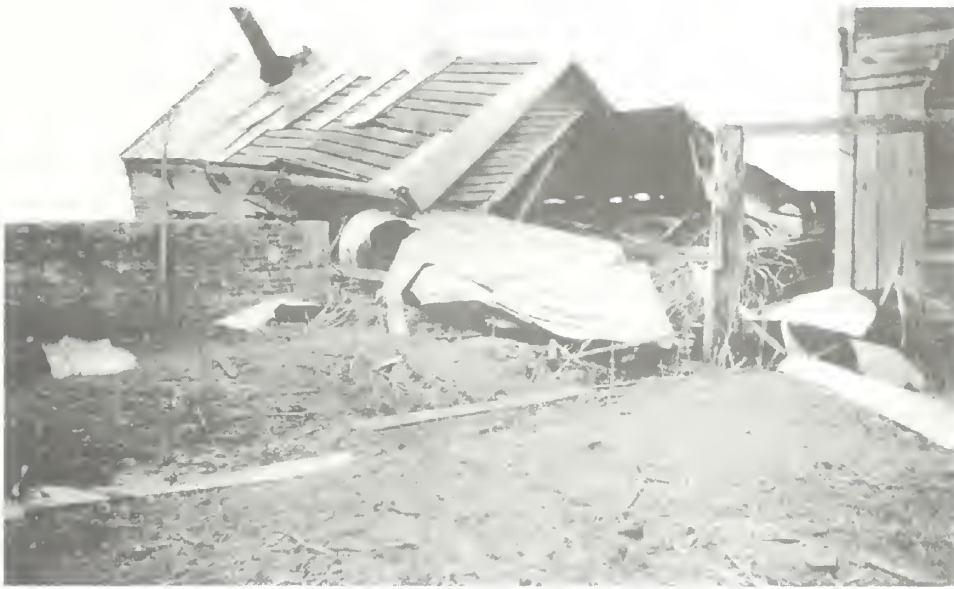
In 1939, the building was damaged by a tornado which also destroyed the adjacent engine house. In making repairs, the building was significantly altered. After the building was acquired by Museum Contents, Inc., in 1977, there were other repairs and alterations. Finally, the NPS replaced the entire roof system in 1996, significantly altering the building's historic character again.

Figure 6 View of destroyed engine house at Gin Barn after 1939 tornado. The barn is partially visible at right. (Hertzog Family Collection, Magnolia Plantation)

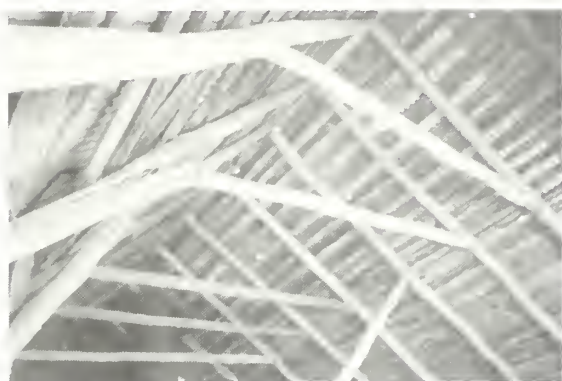
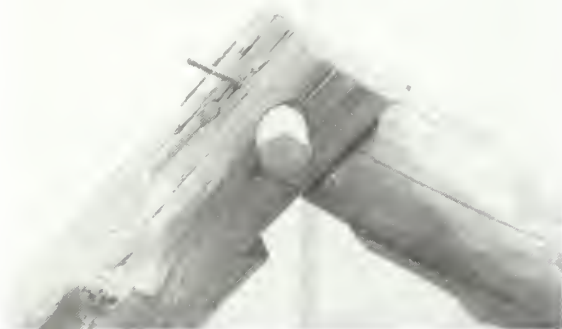
Figure 8 Top, view of original roof prior to its removal in 1995; bottom, detail of salvaged rafters showing lapped and pegged ridge connection. (Upper image, Architectural Division, NPS-SERO, 1994; lower image, NPS-SERO-CRS, 2001)

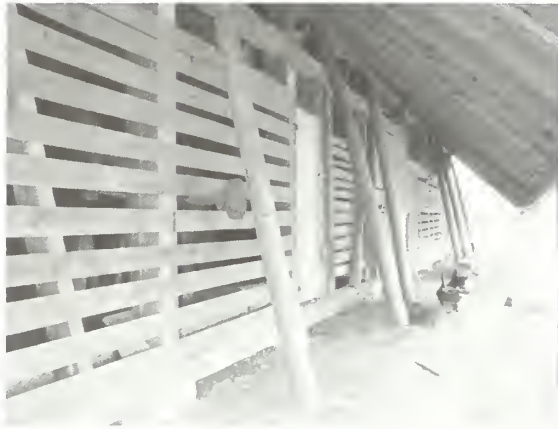
Figure 32 View of north side of building, showing typical open siding. Note that siding near center is attached to the interior face of the studs. (NPS-SERO-CRS, 2001)

- Repair siding as necessary, maintaining lapped siding on ends and on dormers, spaced slat siding on the sides,

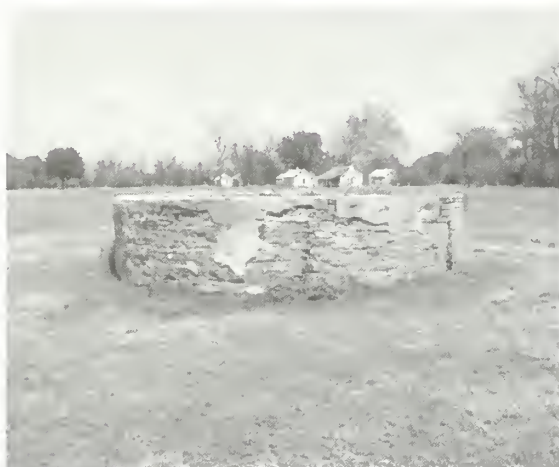
Figure 47 View to northeast of cistern at Gin Barn. (NPS-SERO-CRS, 2001)

- Conduct complete archeological investigation around and within footprint of present building.
- Repair and repoint cistern; preserve engine base.
- Define appropriate routing of visitors around building.
- Keep perimeter of building free of vegetation.

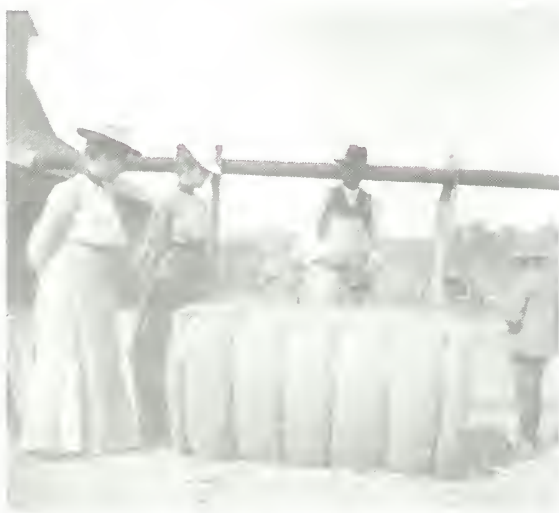
Figure 48 View of Prud'hommes' gin at Oakland, showing elevated flue to transport seed from gin to seed house. A similar apparatus would have been used at the Magnolia gin, but has now disappeared. (NPS-SERO-CRS, 2001)
